CAPTAIN'S REPORT

TUG MACKENZIE ROSE INCIDENT

**UNITED STATES DISTRICT COURT
EASTERN DISTRICT OF VIRGINIA: NORFOLK DIVISION
Case No. 2:24-cv-00490**

July 2, 2025

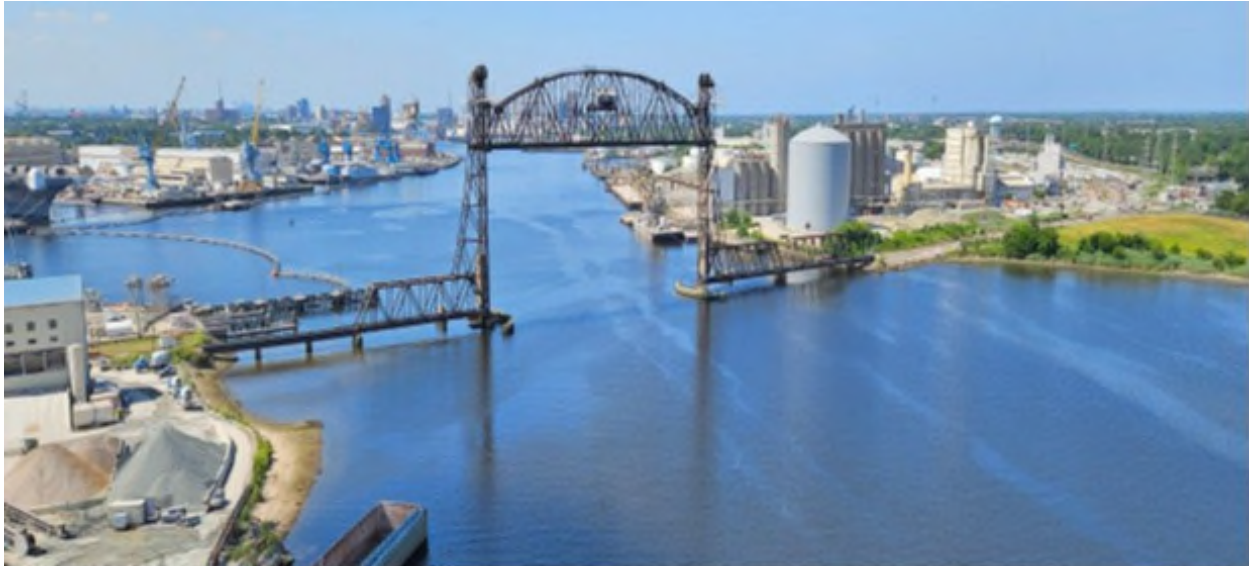
The Norfolk and Portsmouth Belt Line Railroad Company Main Line Railroad Bridge (NPBL Bridge) is in an open position.

NPBL Bridge damage on June 15, 2024
